USACERL Technical Report FM-93/07

January 1993

Corrosion Mitigation and  
Management System

# Corrosion Assessment of an Army Installation Gas Distribution System Using MicroGPIPER

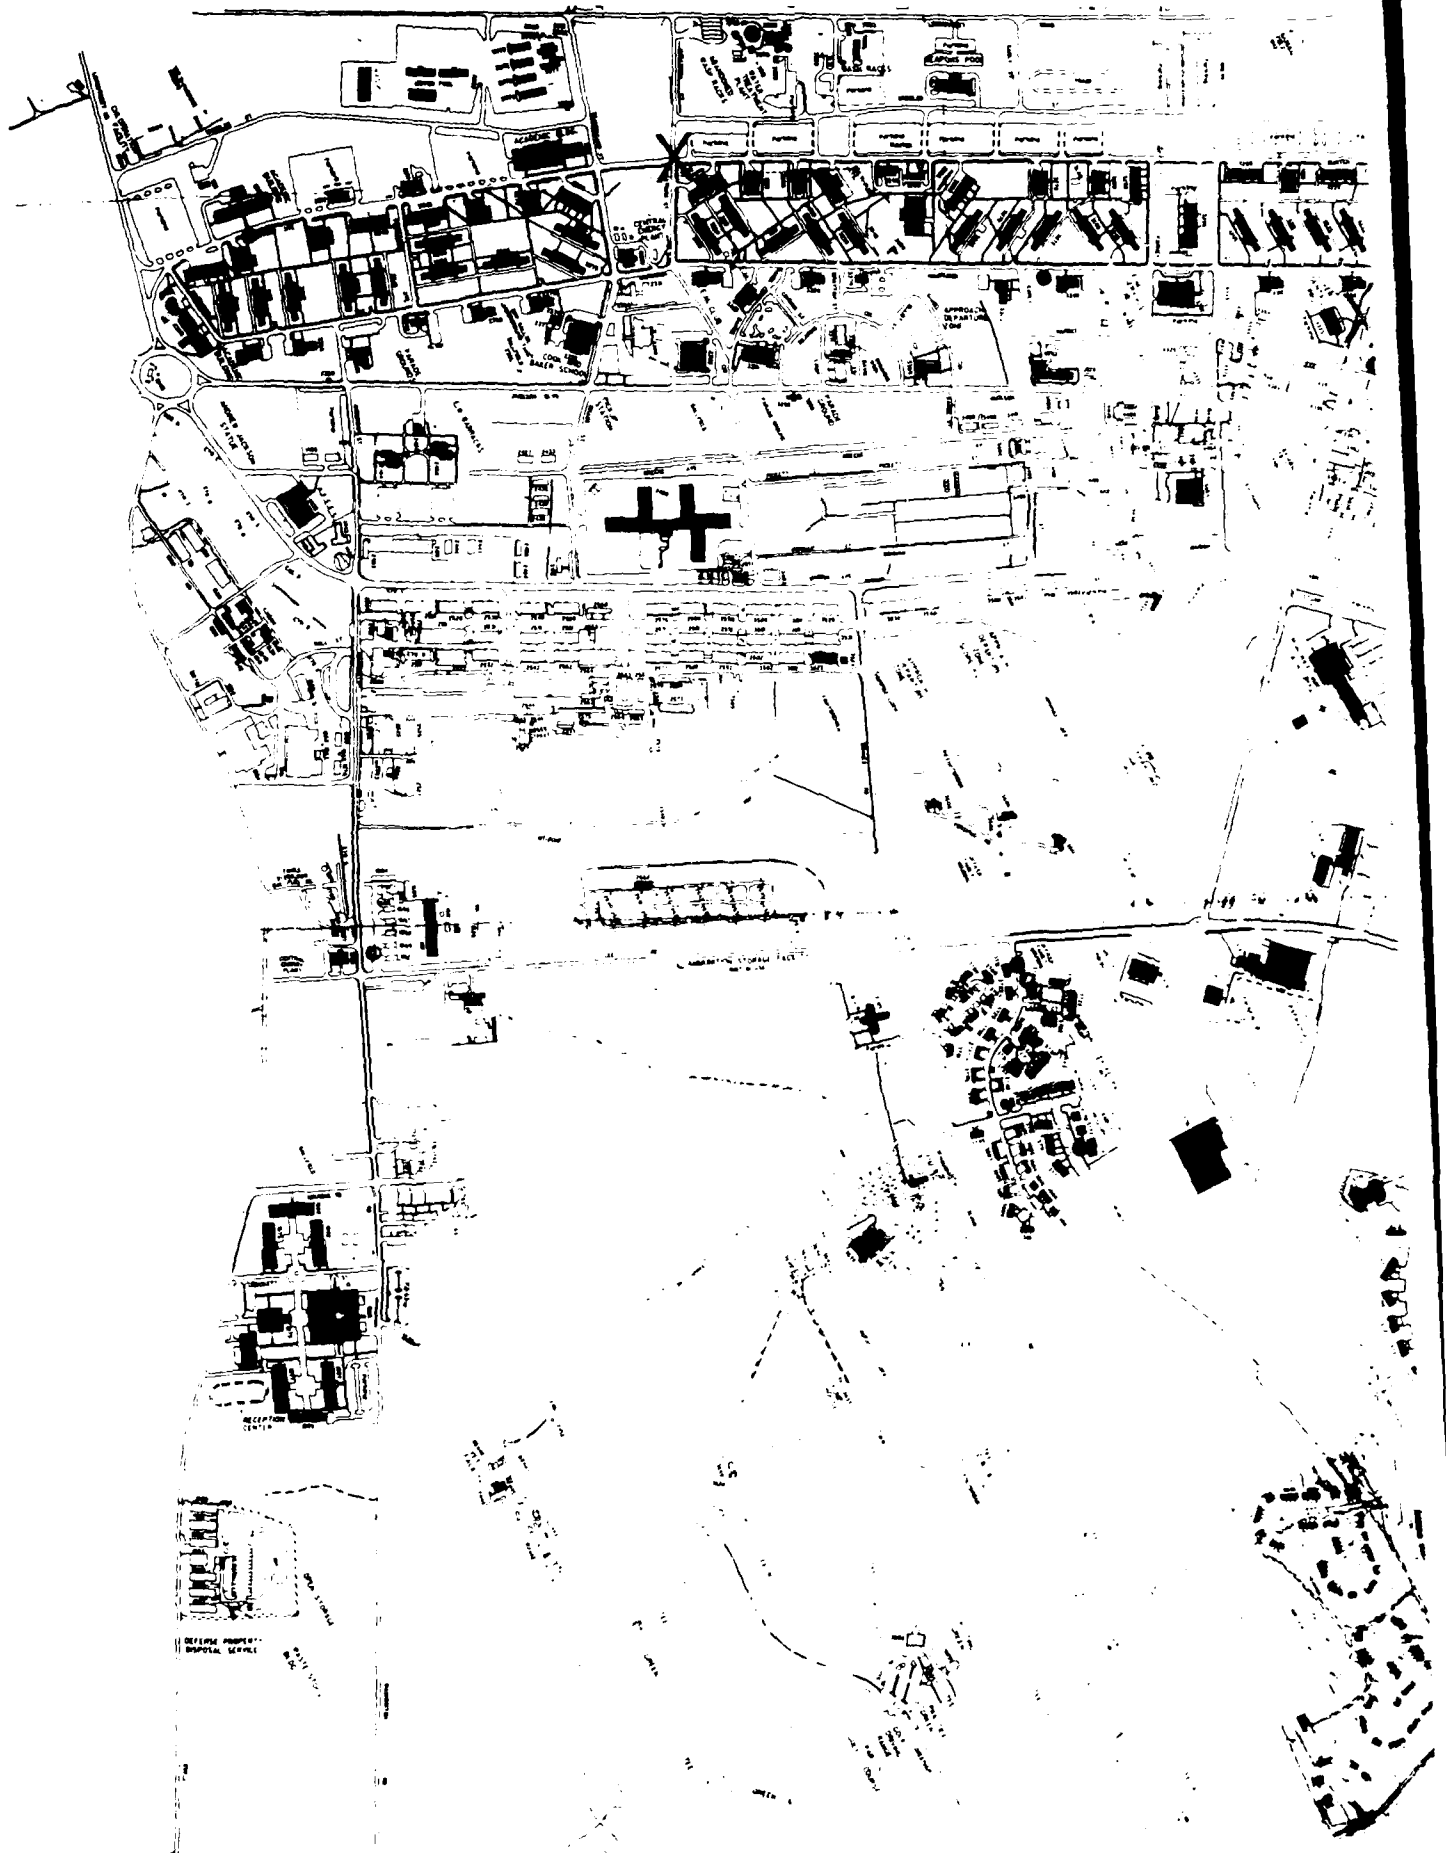
103  
Figure 1. Fort Jackson Site Map.

The July 1991 survey (Southern Cross Corporation 1991) reported a total of 417 leaks, of which 40 were Grade I, 50 were Grade II, and 327 were Grade III. Of the leaks found in this survey, approximately 58 were caused by soil-side corrosion of the mains or service lines. The remaining leaks were primarily caused by faulty valves and fittings which were not in contact with the soil (i.e., they were aboveground, in valve pits, etc.) It is significant to note that 35 of the 40 Grade I leaks were in the group caused by soil-side corrosion. The locations of the leaks caused by soil-side corrosion that were found in the two surveys are plotted on the map in Figure 1.

The leaks were repaired by the Fort Jackson DEH as required.

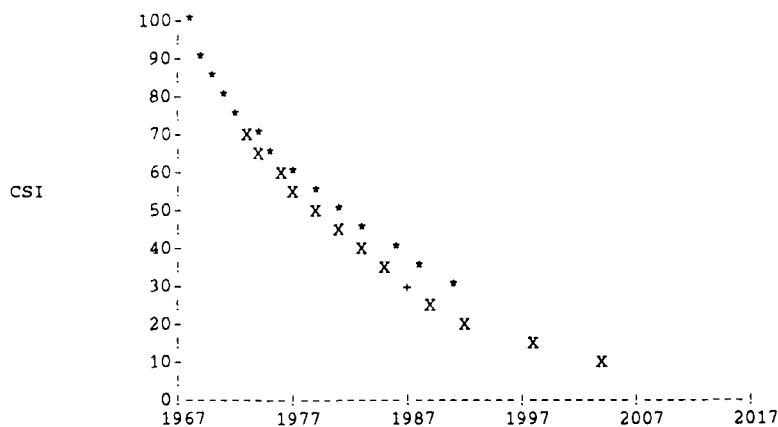
PIPE IDENTIFICATION :	BLDG. 5957	SECTION NUMBER:	1
SOIL RESISTIVITY:	6000.00	SOIL pH:	0.2800
COATING MATERIAL:	WRAP COAL TAR	WALL THICKNESS:	0.2800
YEAR INSTALLED:	1968	PIPE SIZE (OD):	6.0
PREDICTED FIRST LEAD (CSI≤30):	1987	ACTUAL FIRST LEAK:	1991.05.14
Adjusted Formula:	Max.Pit Depth = 0.0454 * (time ^ 0.58)		
Pit Depth (in inches) & Time (in years)

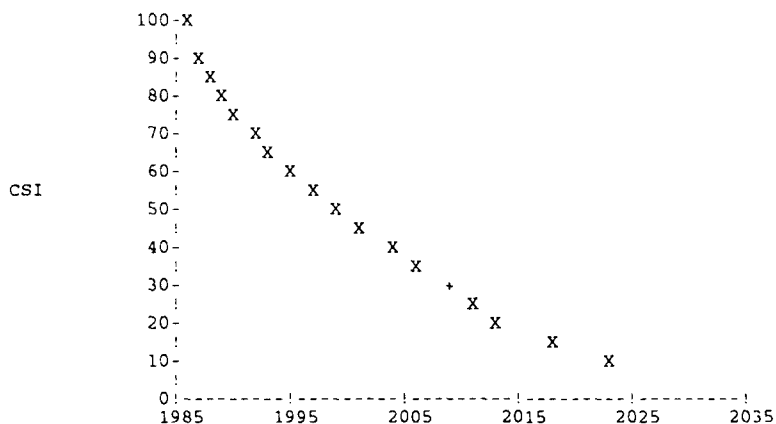
SOIL RESISTIVITY : 5155.00  
 COATING MATERIAL : WRAP COAL TAR  
 YEAR INSTALLED : 1986  
 PREDICTED FIRST LEAK (CSI<=30): 2009

SOIL pH : 5.35  
 WALL THICKNESS: 0.3650  
 PIPE SIZE (OD): 10.0  
 ACTUAL FIRST LEAK: No leak.

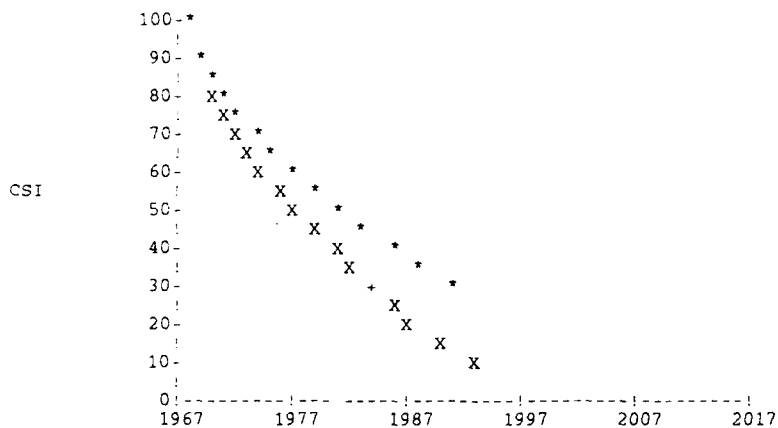
PIPE IDENTIFICATION : FOR&JACKSN SECTION NUMBER: 1  
 SOIL RESISTIVITY : 3053.00 SOIL pH : 5.49  
 COATING MATERIAL : WRAP COAL TAR WALL THICKNESS: 0.1400  
 YEAR INSTALLED : 1968 PIPE SIZE (OD): 1.3  
 PREDICTED FIRST LEAK (CSI<=30): 1984 ACTUAL FIRST LEAK: 1991.08.01

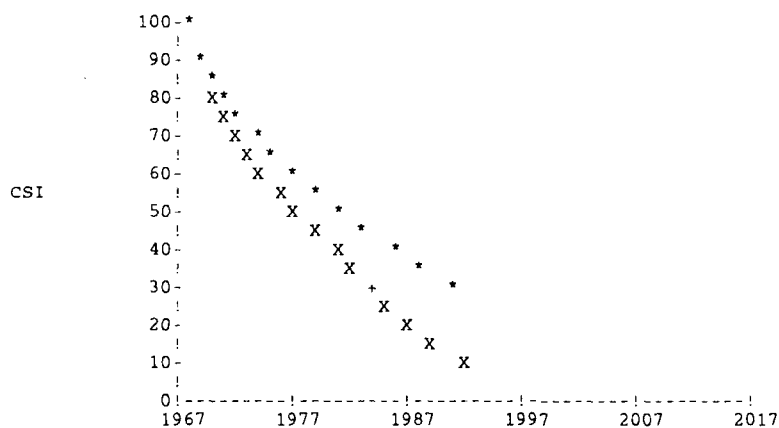
SOIL pH : 4.22  
 WALL THICKNESS: 0.1400  
 PIPE SIZE (OD): 1.3  
 ACTUAL FIRST LEAK: 1991.08.01

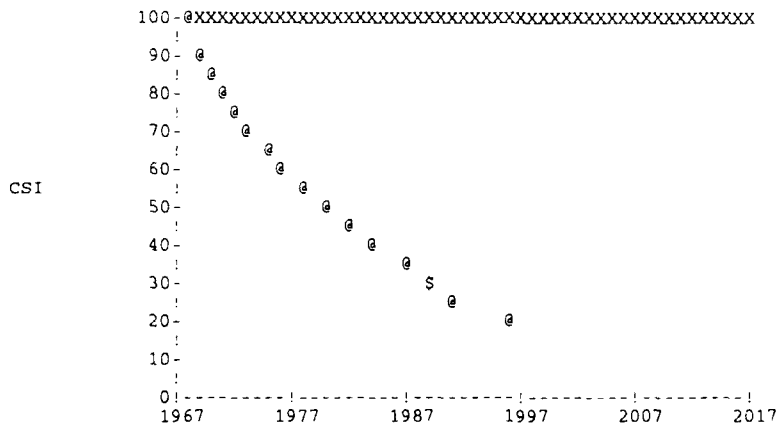
PIPE IDENTIFICATION : FOR&JACKSN SECTION NUMBER: 3  
 SOIL RESISTIVITY : 14493.00 SOIL pH : 5.95  
 COATING MATERIAL : WRAP COAL TAR WALL THICKNESS: 0.3220  
 YEAR INSTALLED : 1968 PIPE SIZE (OD): 8.0  
 PREDICTED FIRST LEAK (CSI<=30): 1989 ACTUAL FIRST LEAK: No leak.  
 CATHODIC PROTECTION w/ PIPE-to-SOIL POTENTIAL <= -0.85 VOLTS

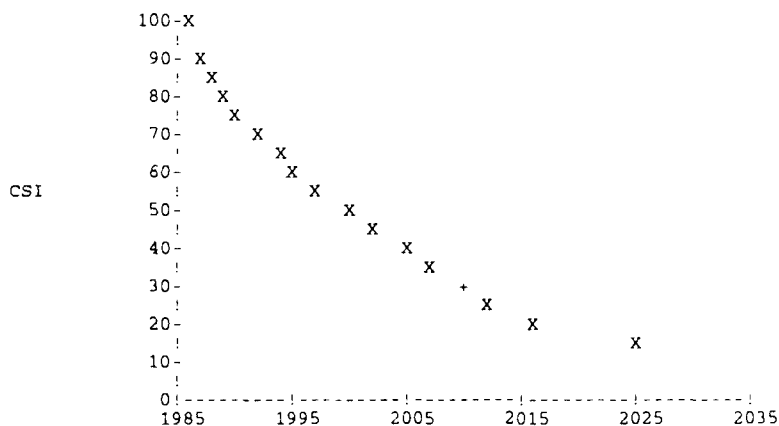
PIPE IDENTIFICATION : SUMP&CHEAT	SECTION NUMBER: 1
SOIL RESISTIVITY : 7067.00	SOIL pH : 6.67
COATING MATERIAL : WRAP COAL TAR	WALL THICKNESS: 0.3650
YEAR INSTALLED : 1986	PIPE SIZE (OD): 10.0
PREDICTED FIRST LEAK (CSI<=30): 2010	ACTUAL FIRST LEAK: No leak.
